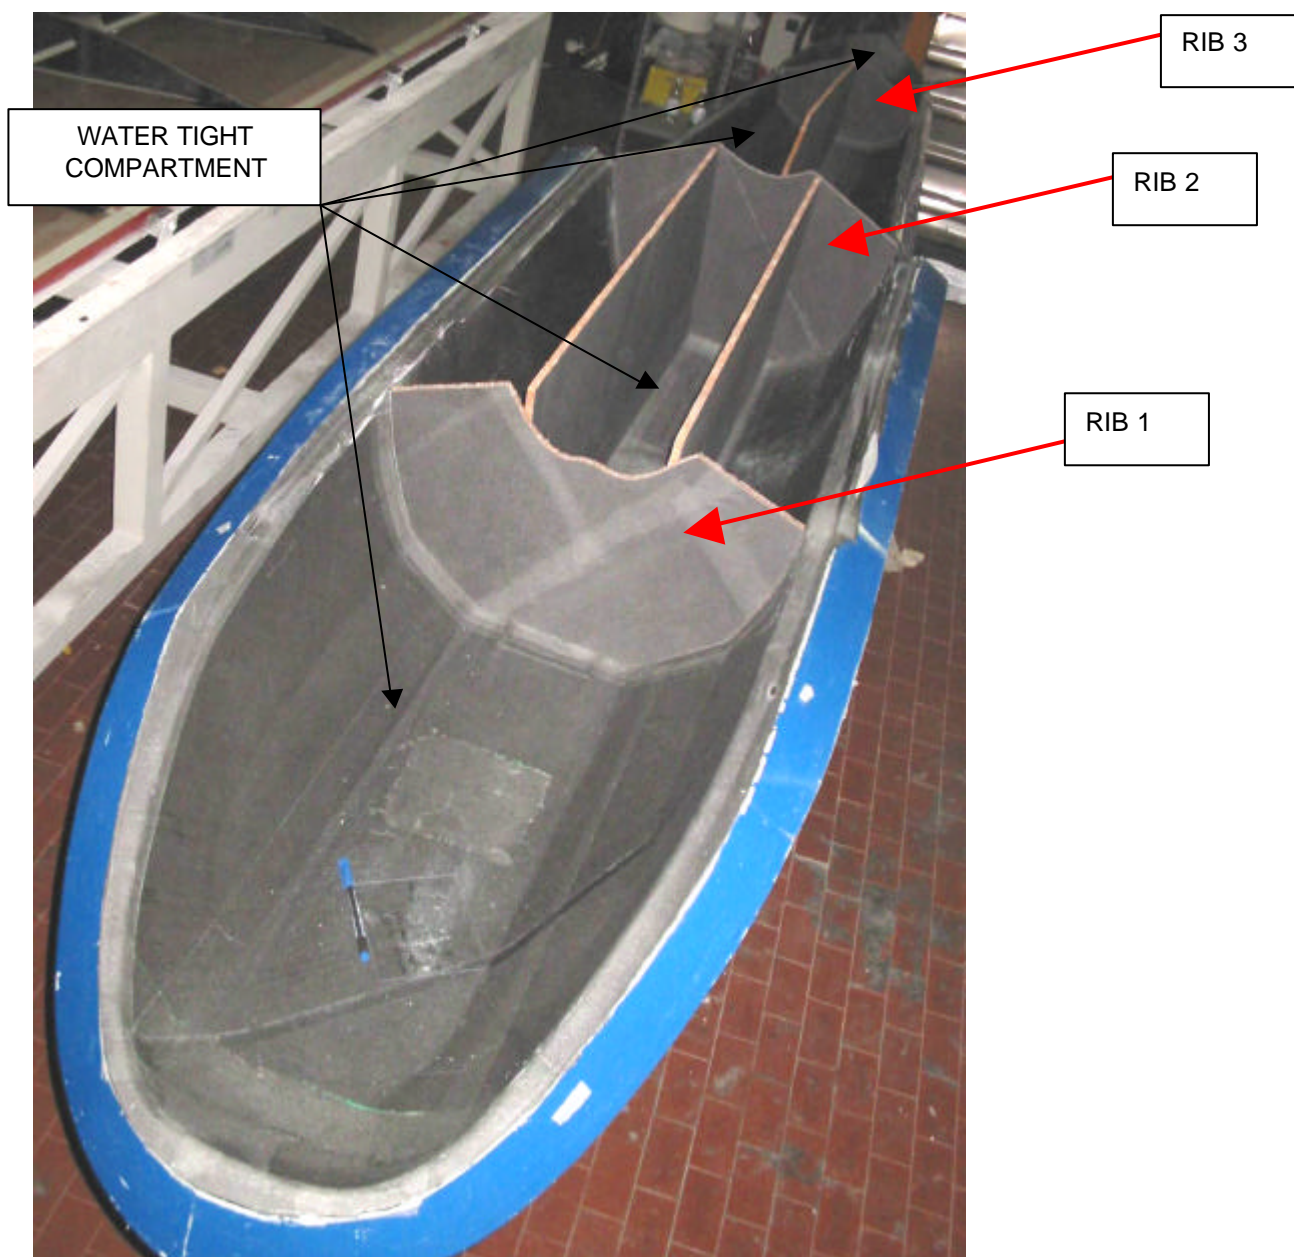
THE PICTURE BELOW SHOWS THE RIBS, AS INDICATED IN THE CAD DRAWING..
 ALSO SHOWN ARE THE FOUR WATER TIGHT COMPARTMENTS; THE THREE VANES IN THE CENTRAL COMPARTMENT ARE CONNECTED.
 THE PICTURE SHOWS THE UPPER SURFACE INSIDE THE MOULD
